Skipton Town Hall with Craven Museum

A Conservation Statement and Appraisal,
towards production of a
Conservation Management Plan

Susan Wrathmell, MA, IHBC

October 2013

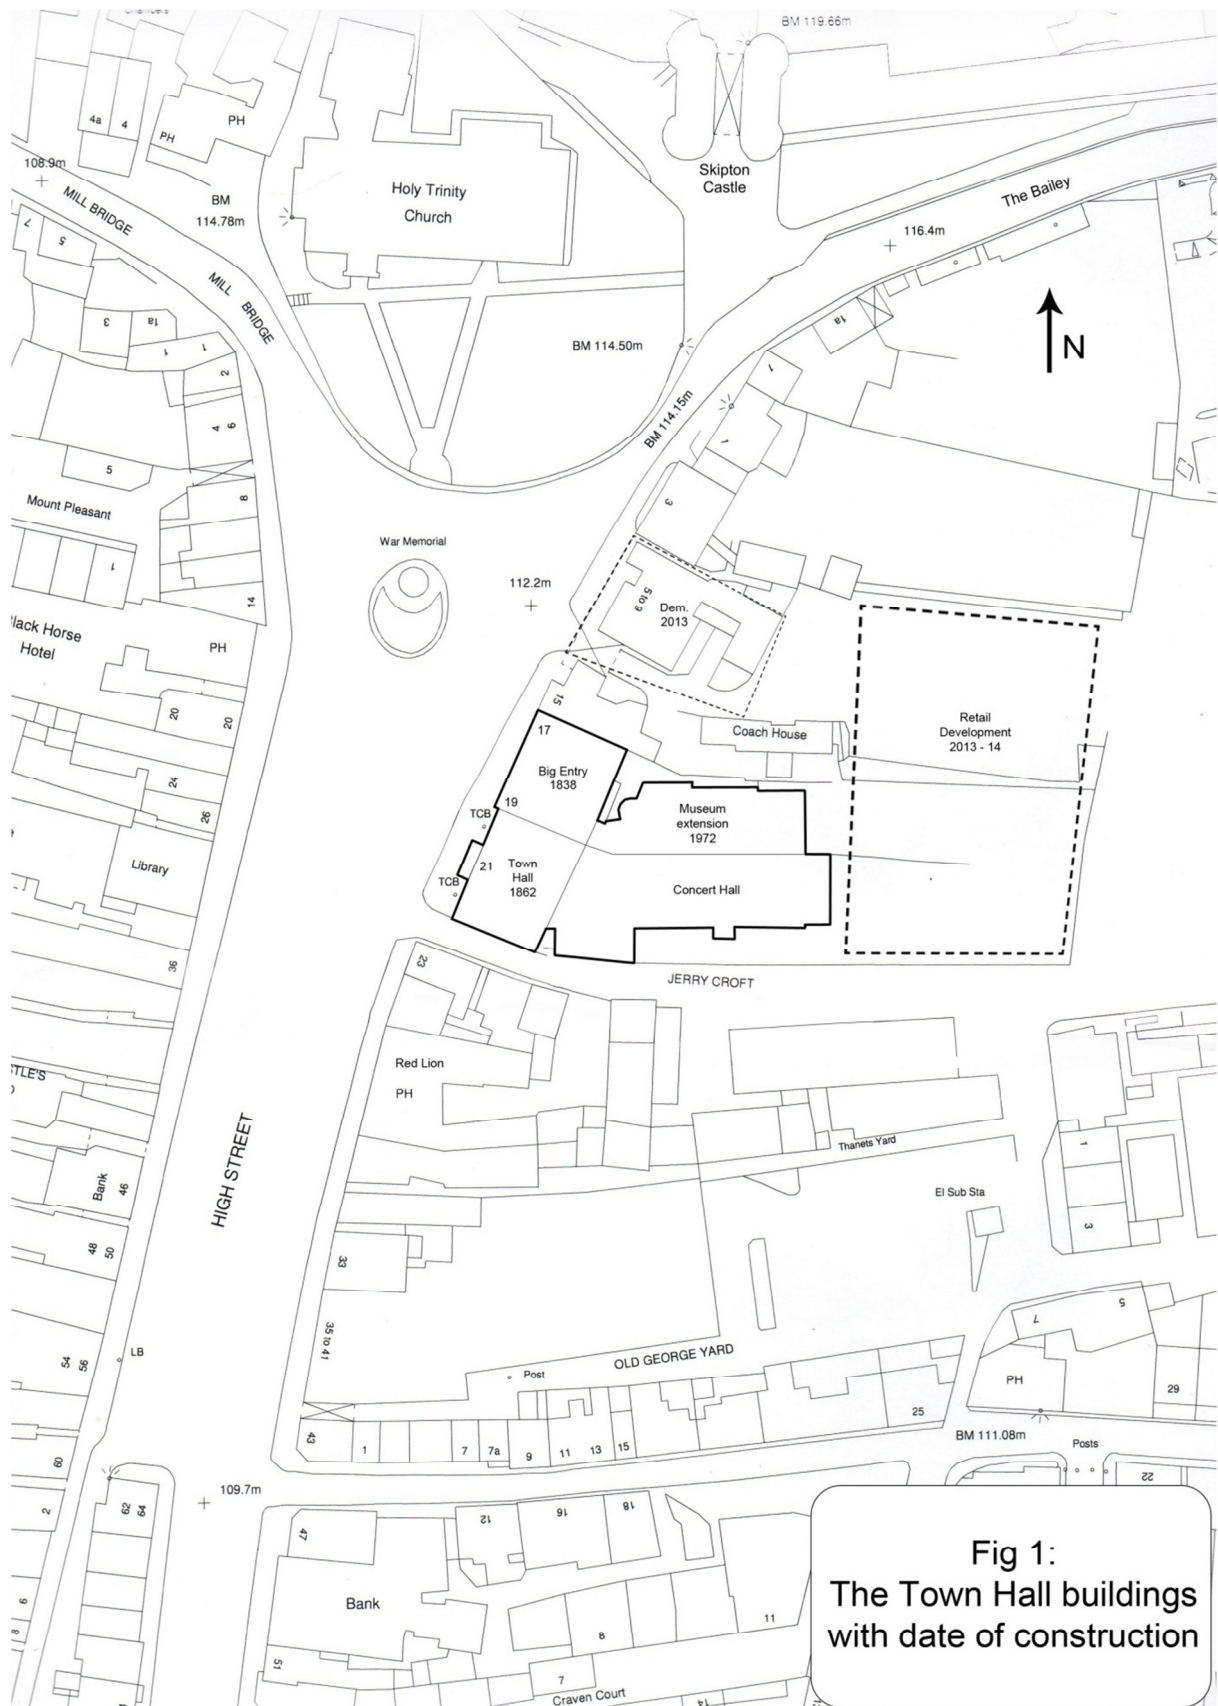
Modern map showing Town Hall with building dates. Room plans: Figs. 40-46

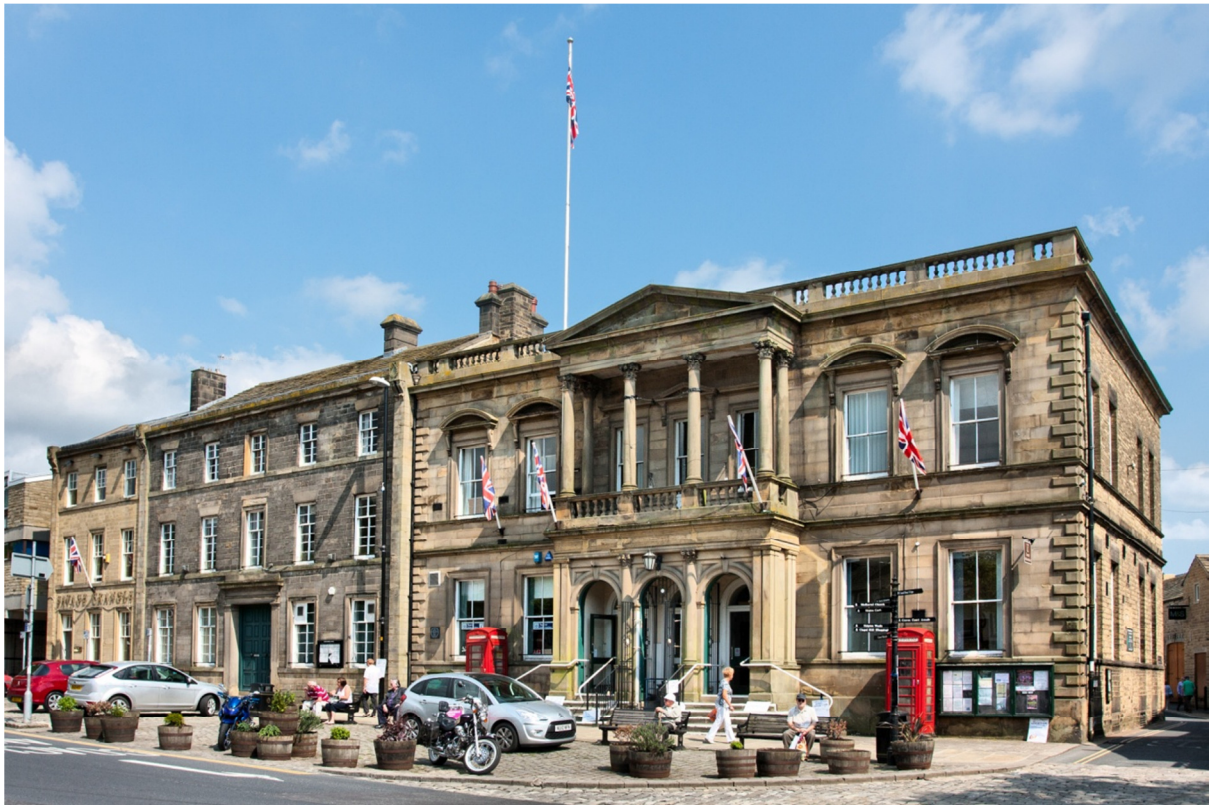
Fig. 2 Town Hall façade, no.21 High Street. Big Entry, nos. 17 and 19 to left. In 1837 an old house on the medieval burgage plot was pulled down and two houses separated by a wide carriage arch, soon known as 'Big Entry' were built next door to the Holy Trinity vicarage in 1838. Farmer David and Mary Dale lived in the left side, William Metcalfe, a Manchester brush manufacturer, lived in the right. See census returns in Section 3.6.1 The old vicarage site next door was sold to the Skipton Building Company a few years later and in 1861 building began on a new Town Hall, celebrated by local business people and visitors alike. TH

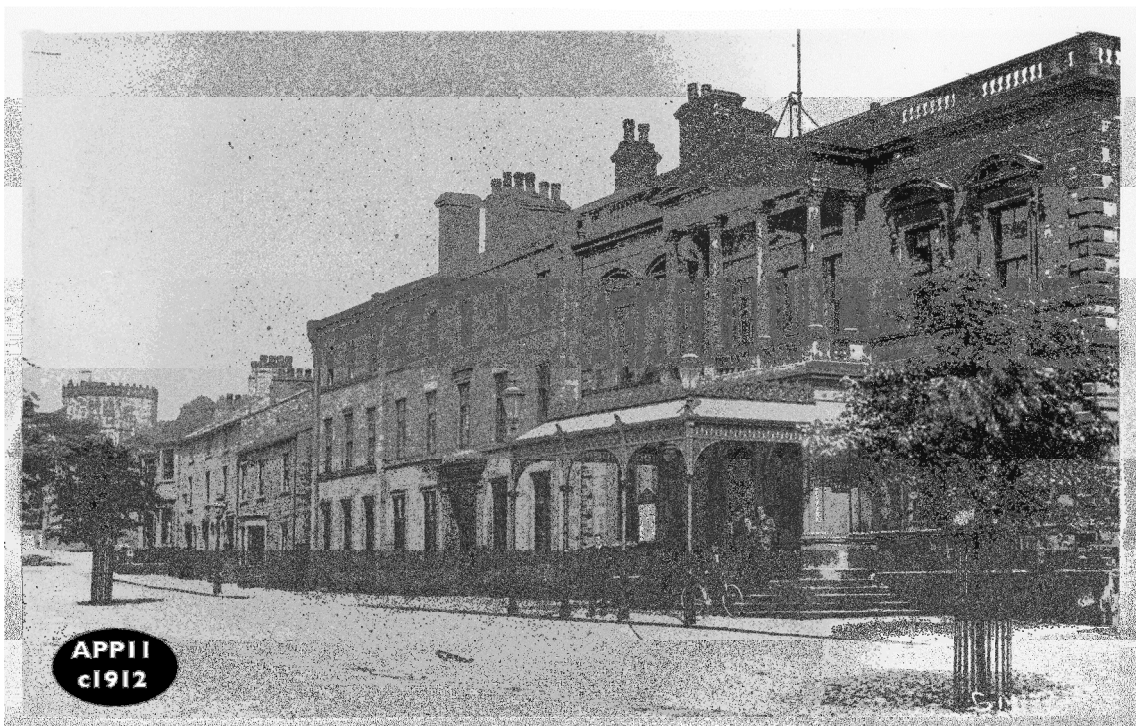
Fig 4 Town Hall, Big Entry, nos. 3, 5.7 and 9 High Street. Photo 1900-1915. Town Hall staff are standing on the steps, the caretaker in uniform. Canopy built in 1900 and taken down in 1956, see Appendix 6 Time Line.

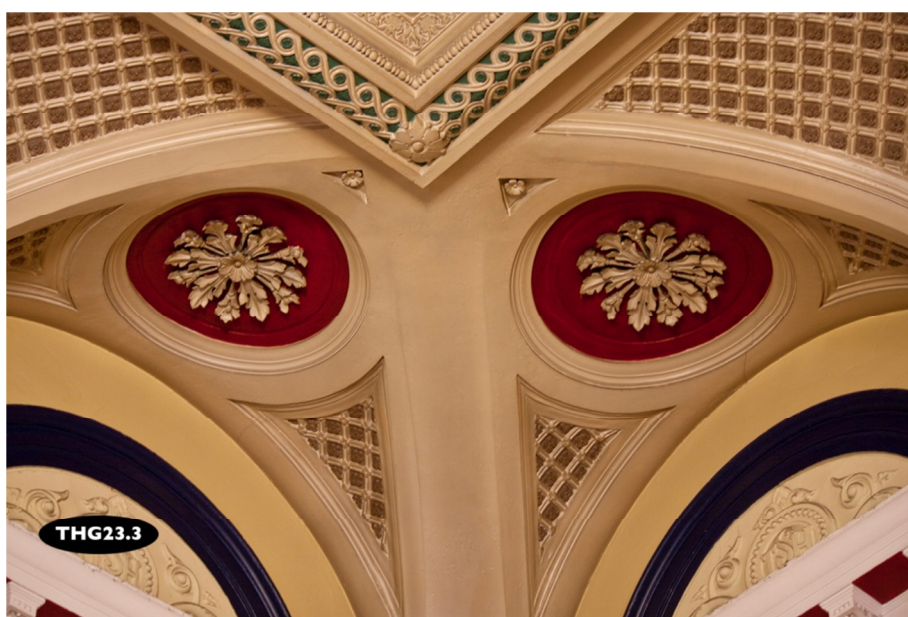
Fig 5 Improved Town Hall ceiling, part of the 'beautiful enrichment' by Lockwood & Mawson of Bradford, 1875-'76.RH

C19 and C20 alterations (see Appendix 6). The chronology of change for the concert hall and its lobby area includes a substantial re-ordering to designs by Bradford architects Lockwood & Mawson in 1875-78. They provided a more impressive interior to the concert hall, including the higher tier of windows and the elaborate plaster ceiling replaced an earlier and lower roof of 'national-school style'. In the 1890s there were local government changes and the council chamber underwent alterations (not yet fully understood but possibly the date for removal of a cross wall and the present ceiling and fenestration changes, forming the large room we see today).

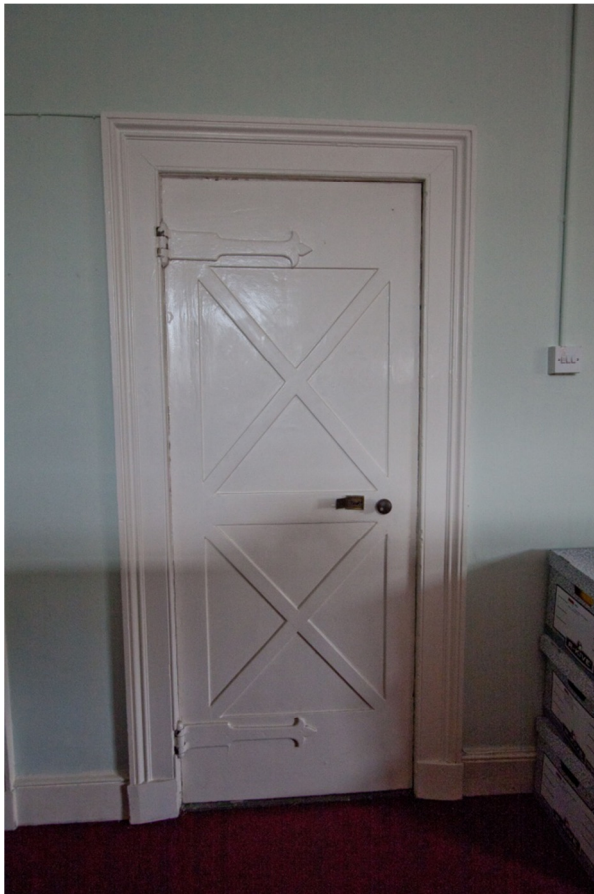
Fig 6 Original strong-room door, first floor. See Appendix 1, F7, D15.

Three rooms in the 1862 Town Hall (G 15, G16 and F7) were purpose-built strong-rooms, with solid brick or stone walls and steel doors. The ground floor rooms are still in use and room G16 contains archive material. The key to F7, (directly above G15) have not yet been found. Master lock-smiths J.H.Blakey & Sons of Briarfield, have quoted for work to gain access.

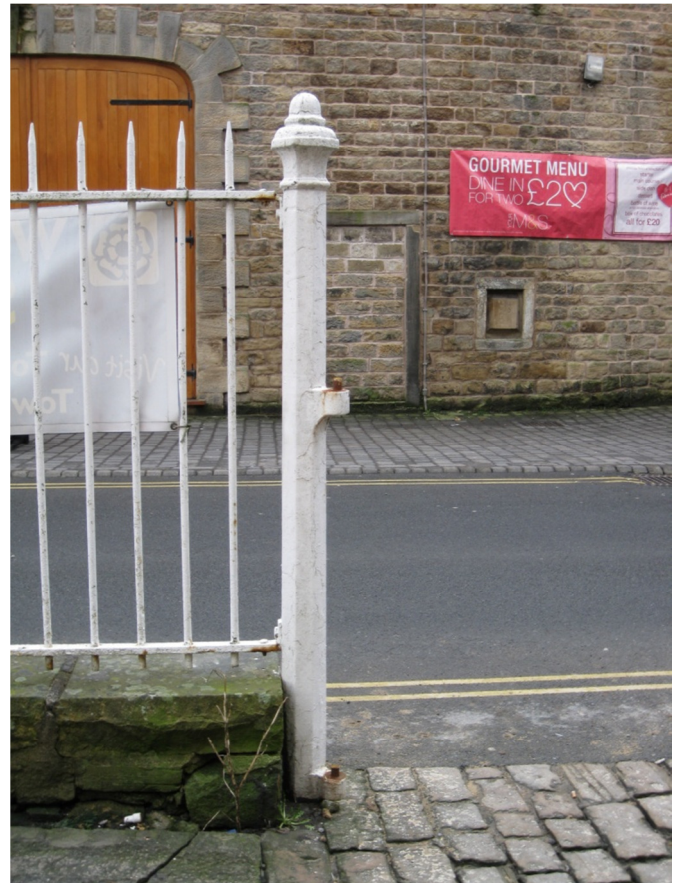
Fig 7 Original gate post south side, probably re-positioned c1960.

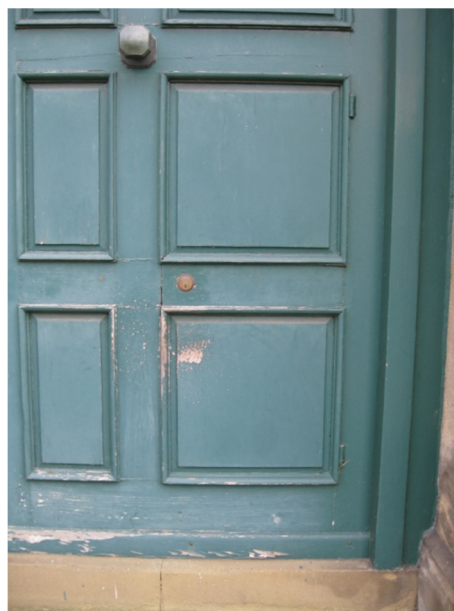
Fig. 8 Wicket-gate in double doors of the 1838 Big Entry. Doors sealed up in 1962 when the staircase was inserted into the passage and the building was linked to the 1862 Town Hall. The door style dates from the 1930s.

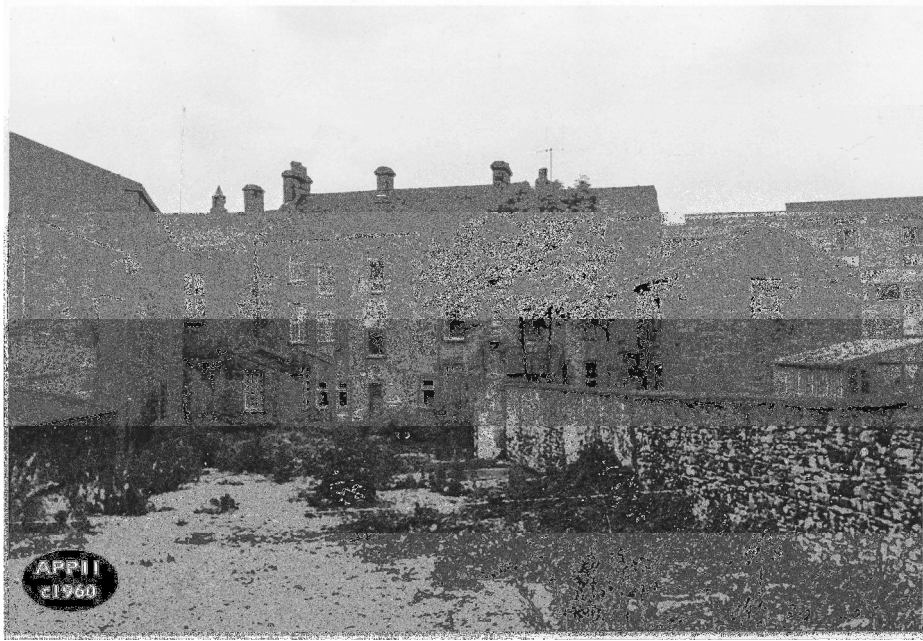
Fig 9 View of the Town Hall and rear wall of the Big Entry showing blocked archway and staircase windows. Before the Craven Museum annexe was built in 1972-'73. DW

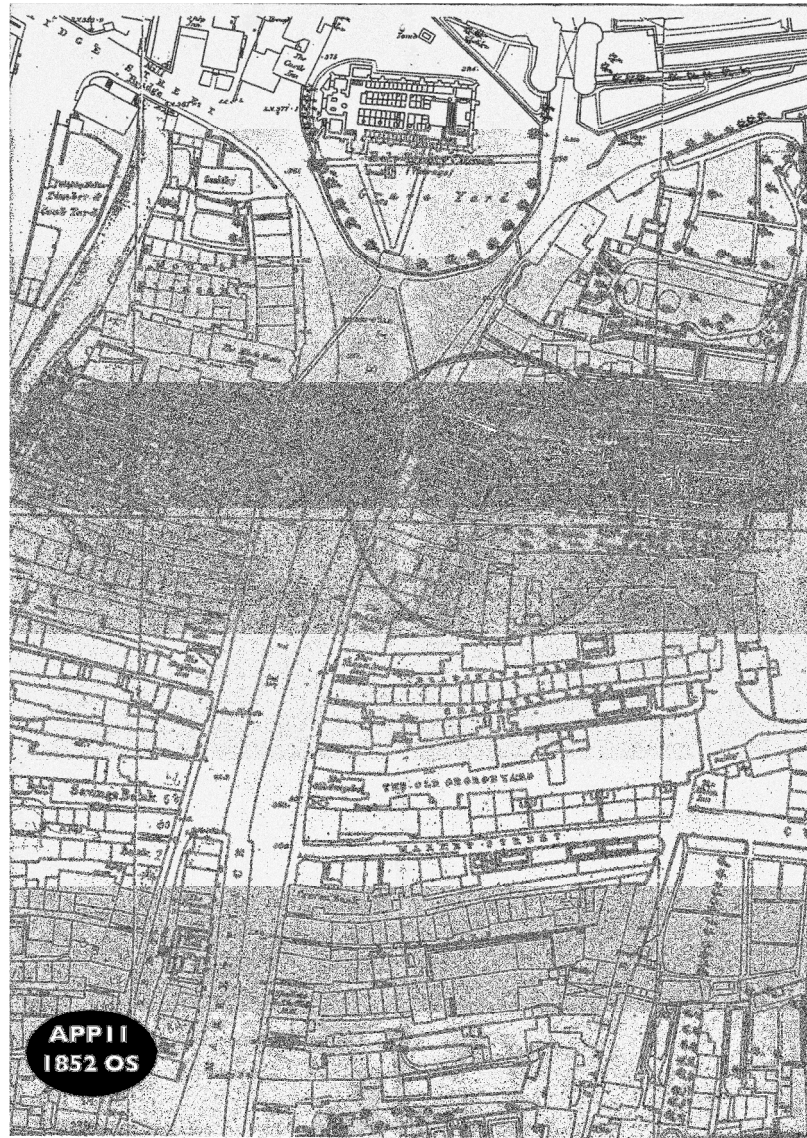
Fig 10. Ordnance Survey map 1852 showing the Holy Trinity vicarage and gardens, site of the new Town Hall in 1862.

3.2.1 Mid 19th century (see Figs 10 and 11)

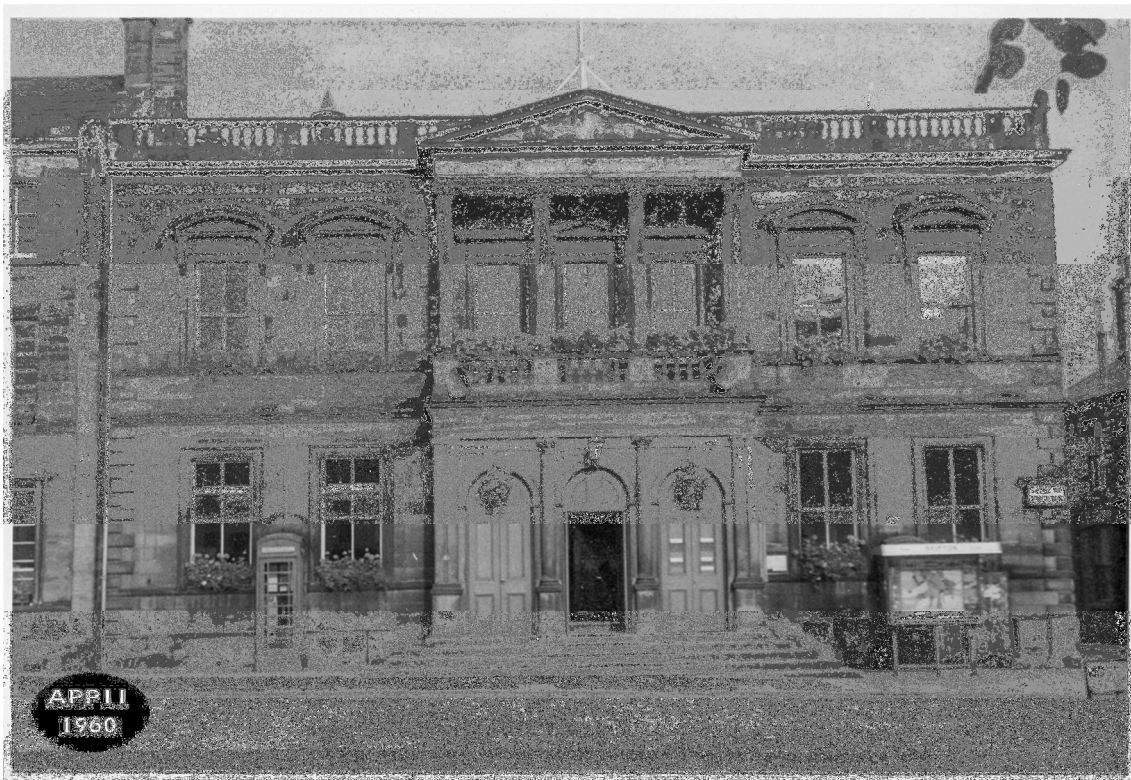
Fig 13 Town Hall front in 1960, ten years after removal of the canopy, these original doors were replaced in 1961. Note the roof ventilator for the Council Chamber. See Appendix 6, Time Line and Appendix 11 archive photographs.

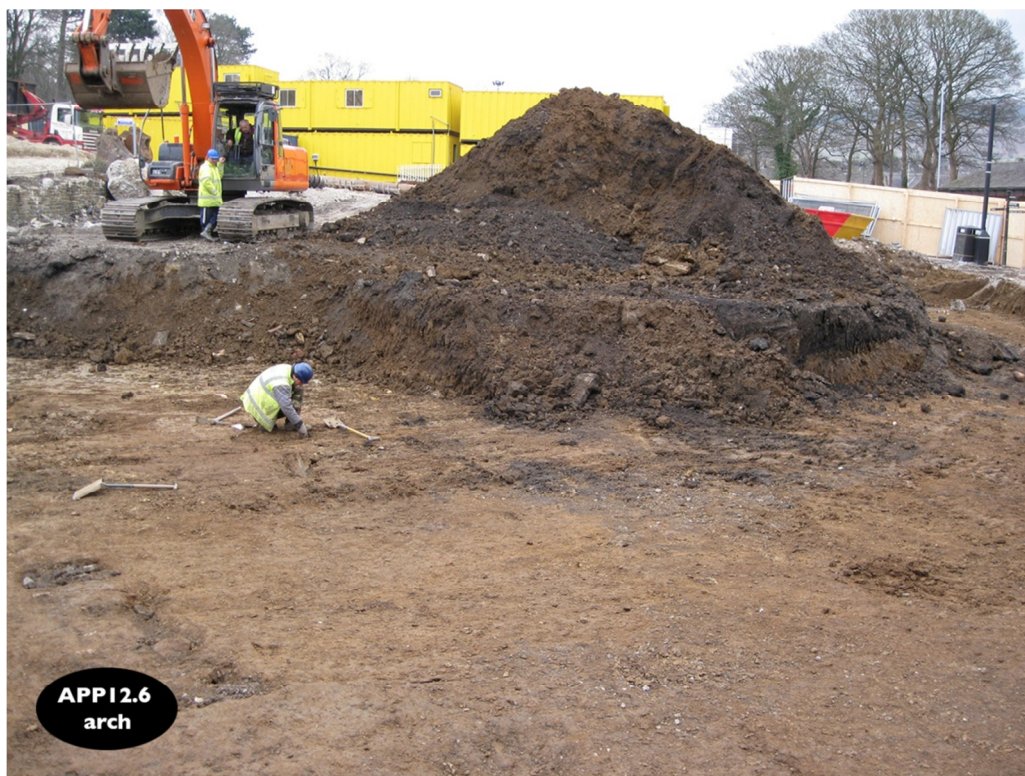
Fig 15 Archaeological investigation on the Town Hall garden site, February 2013.

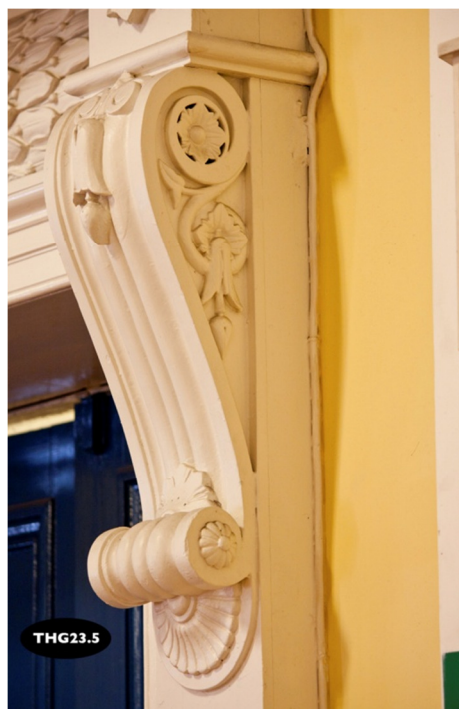
Fig 19. One of the elaborate console brackets for the main concert hall entrance. A list of the craftsmen working on Lockwood & Mawson’s new hall was published in the Craven Pioneer on May 8th 1875. Joinery was by J.Pettyt of Skipton, Benjamin Dixon of Bradford did the plasterwork. RH

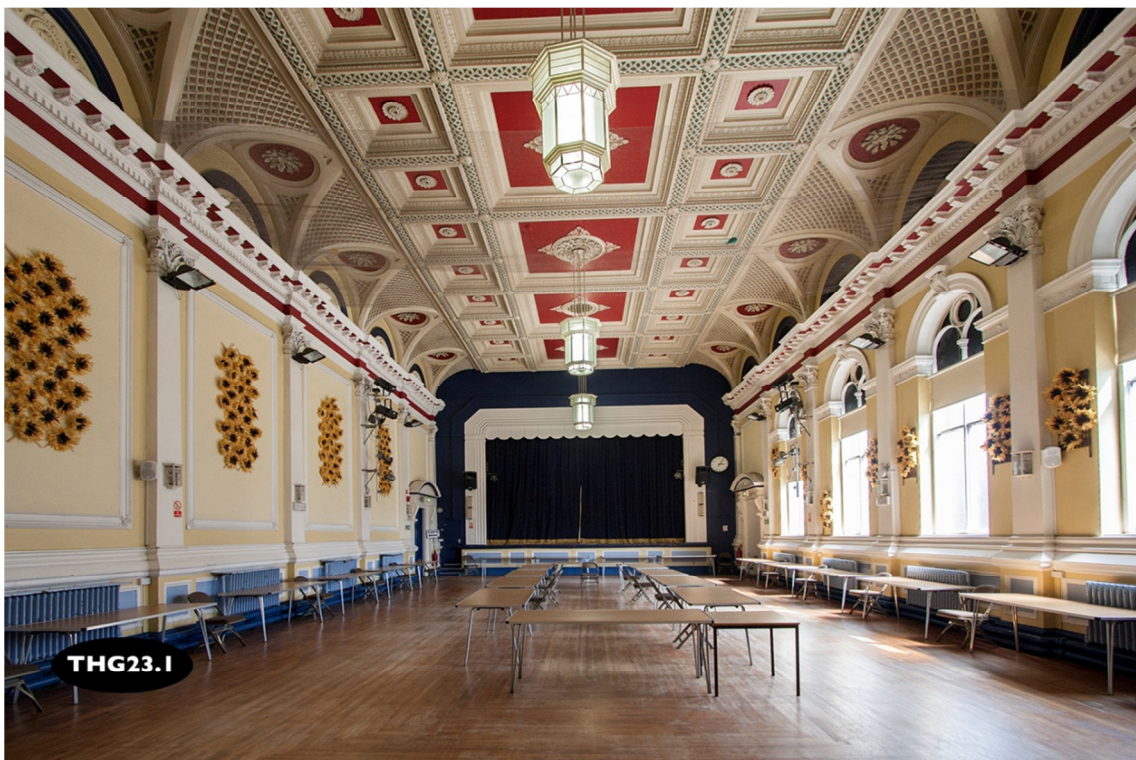
Fig 20. 1876 hall; lights and proscenium arch probably 1933, when the pillars were marbled and the stage made larger. Maplewood floor 1956. Poor later treatment with insensitive down-light fittings, blocked upper window lights, netting to catch falling plaster, mouldings cased in, colour scheme highlighting ugly radiators, inappropriate decorations. See Appendix 6 Time-Line and 11 archive photographs for the 1927 interior. RH

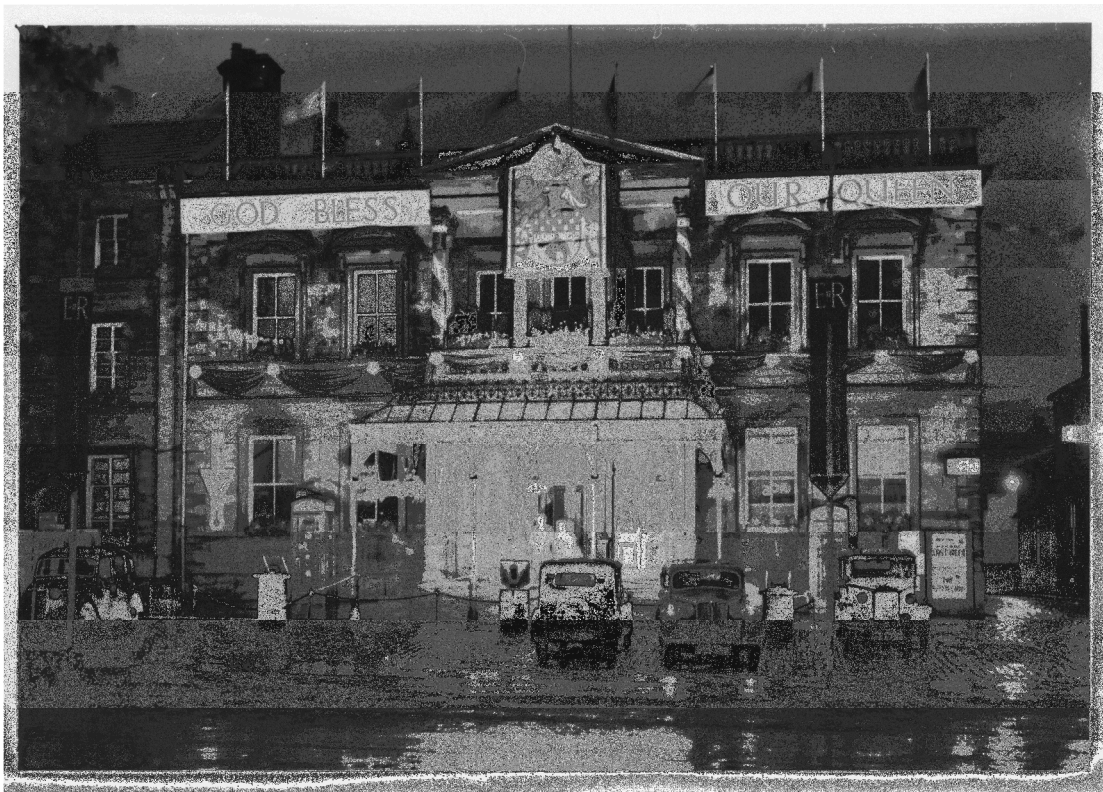
Fig 21 Archive photograph showing the decorated front in 1953. The canopy gas-lights have gone and structure was removed in 1956 after repeated damage by cars.

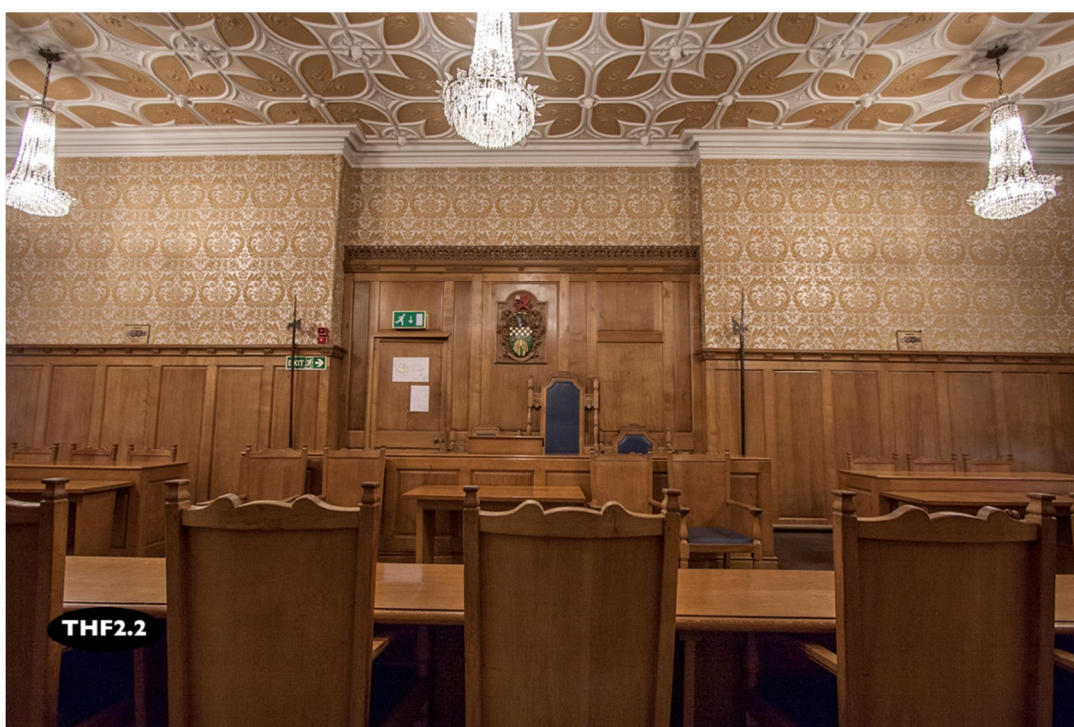
Fig 22 The Town Hall's centenary was marked by extensive alterations. In 1961 the Council Chamber was refurbished, Robert Thompson of Kilburn quoted for delivery and fixing of panelling, platform, lockers, benches, tables, chairs, curtain boxes. The wallpaper and decorative scheme are probably of that date. The ceiling and cornice are probably later 19th century. Panelling left and right conceals fireplaces and the door leads into the 1838 Big Entry building, taken over entirely for council use by 1963. There is a mouse carved on the back of the right-hand chair. RH

The cost of a complete re-fitting of the Council Chamber (£2738.0.0d) was provided to the council on December 7th 1960¹³ and is printed in full in Appendix 3. It takes the form of a single ruled page apparently from an order book, reference no. '107' top left, hand written, no company name or signature. It was addressed to Mr K. B. Robinson, Engineer and Surveyor, Town Hall, Skipton, Yorks. Items of furniture display the characteristic 'Mouseman' detail. See Appendix 6, Time Line.

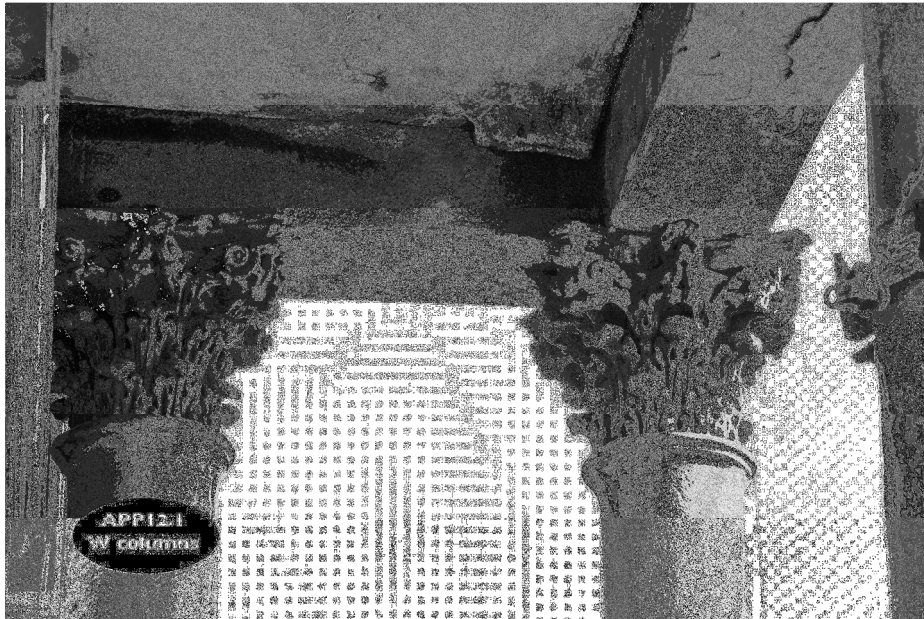
Fig 29 Mr Jee's elaborately carved classical capitals on the balcony, 1862, with a view of the stone decay. RH

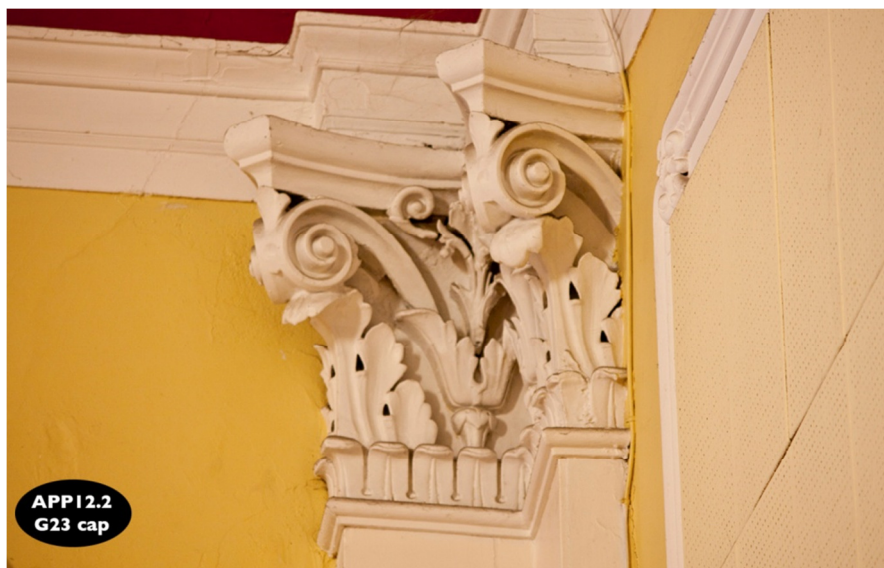
Fig 30 Pilasters in main hall: acanthus leaves and scrolls, designed by Lockwood & Mawson, 1875. RH

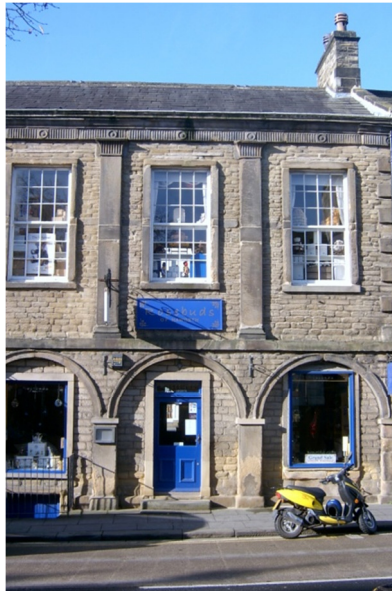
Fig 31 Skipton's Old Moot Hall or Town Hall. Late medieval cellars used as cells, round arches based on medieval market hall style, court room and offices for collection of market rents above. Classical style of c1790 with pilasters and tall sash windows. The 1862 Town Hall was much larger.

The old Town Hall or 'Moot Hall' remains on its late medieval site in Middle Row and has strong classical detailing with pilasters, pedimented entrance, round arched ground floor and tall first floor sash windows, its present form dating from the later 18th century. Other pedimented doorways can be seen elsewhere in the town.

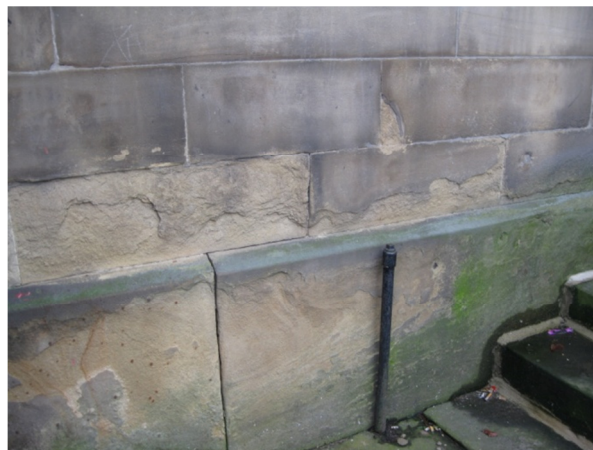
There is surplus wiring, old notice fixings, stonework damage; erosion and staining; poor quality pointing.

Fig. 33 Front wall base next to the entrance steps: surface stone erosion and lamination.

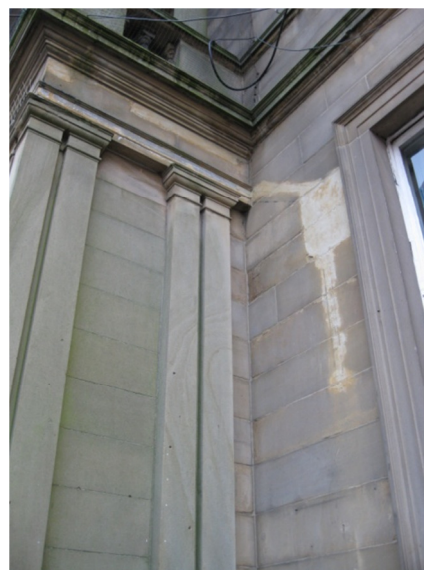
Fig. 34 Front wall: loose wires, redundant fixings, and poor repair following removal of the glazed canopy in 1956.

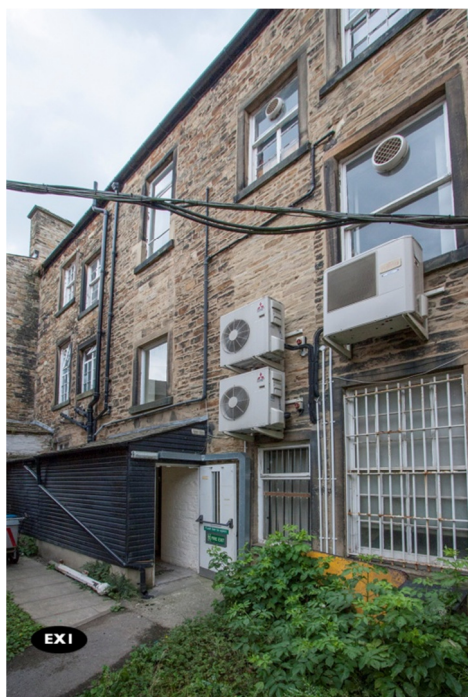
- 1838 'Big Entry': front wall centre bulge and cracking on inside; water ingress at eaves.

Fig. 32 Rear view of the Big Entry. 20th century needs for access, ventilation and security have almost destroyed the attractive balanced elevation. Compare with Fig.9.

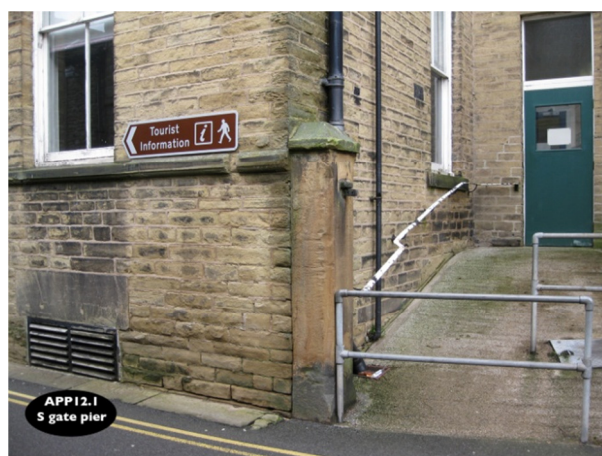
Fig. 33 Entrance from Jerry Croft. Blackened walling reveals the old boiler house cellar ventilation. An original stone gate post (see Fig.17) and ugly pipework, handrail, safety fence, emergency exit. Original area steps to the basement survive under the steep concrete ramp. See App 1 Rooms B4 and B5.

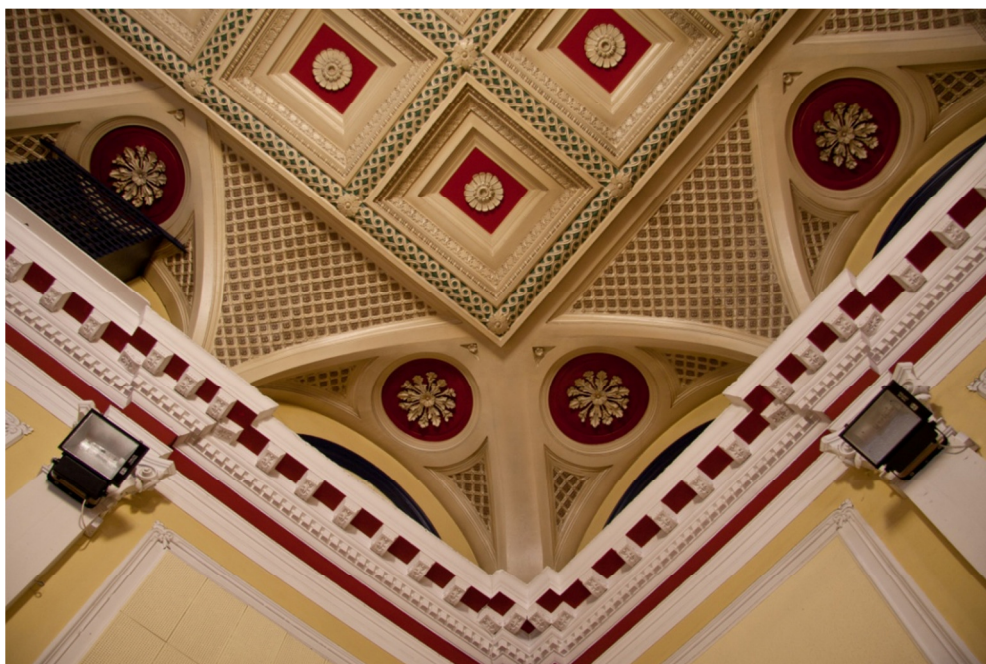
Fig. 34 Main hall ceiling detail. See Appendix 1, Room G23. High Victorian decorative plasterwork, 20th century colour schemes.
